SUB29 Hare Lane Carpark

Site Historic Environment Assessments for Strategic  
Assessment of Land Availability (SALA)

June 2016

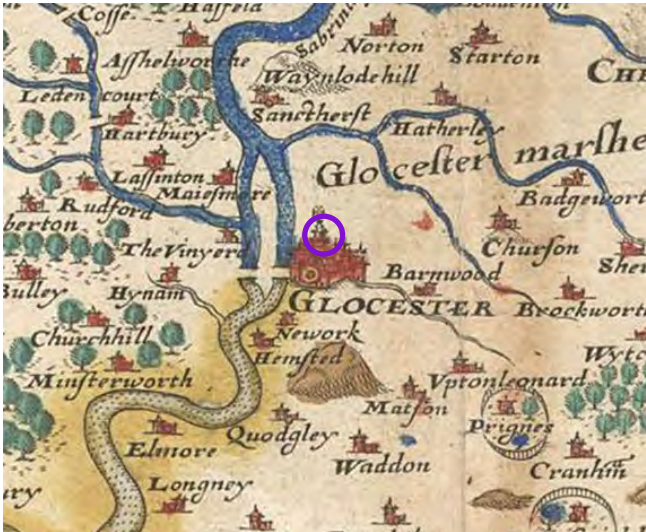
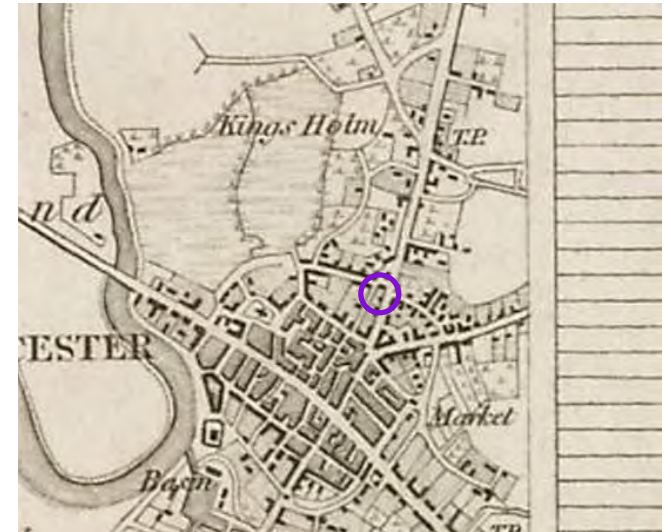
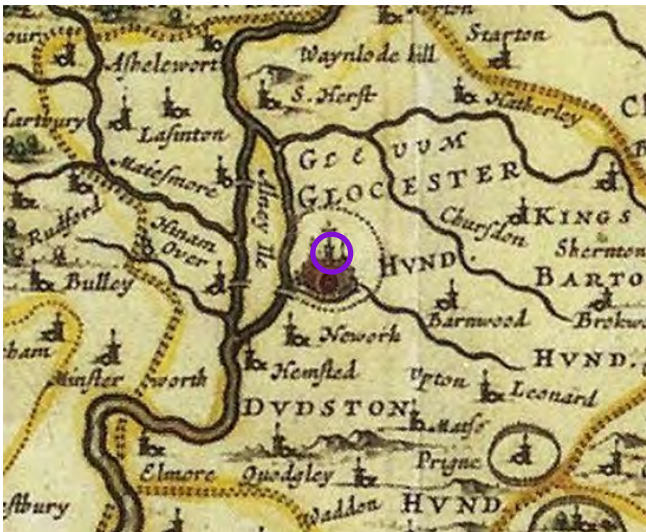
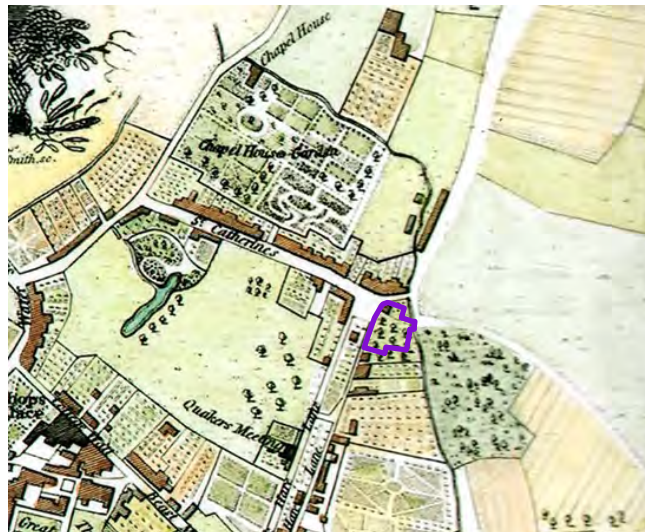
Figure 3 - Historical mapping

The earliest historic maps of the area of the SUB29 site are not very detailed. The Saxton map (Fig 3) of the later 16<sup>th</sup> century shows only settlements with churches and the River Severn with Gloucester very prominent. Kingsholm is not separately shown on this map, nor is it shown on the 1646 Blaeu map (Fig 3) which is very similar. The 1794 Cary map (Fig 3) includes roads and shows Gloucester prominently but does not have any other detail of the city. The first map showing any detail of the area is a 1799 map of Gloucester which shows the SUB29 site as an open area with buildings along both Hare Lane and St Catherine Street and gardens to the north and south of St Catherine Street. The 1805 Cole and Roper plan (Fig 3) shows the SUB29 site as an orchard with a small structure in its south west corner. The buildings of Hare Lane and St Catherine Street are clearly visible on this plan and the gardens to the north of the latter are labelled 'Chapel House Garden'. The scale of the 1831 Ordnance Survey (Fig 3) is too small to show a great amount of detail but it does show the built up area of St Catherine Street. The new Worcester Street is clearly visible running out to Kingsholm. The 1852 Board of Health maps (Fig 3) of the area show that by this time the frontage of Hare Lane within the SUB29 site had been built up leaving the back plots as gardens. A hedge line crosses the southern area of the site and a small shed or outhouse is near this in the east. The railway viaduct is clearly shown crossing this map along with the built-up areas of the south part of Hare Lane and the northern side of St Catherine Street.

The Ordnance Survey 1<sup>st</sup> edition of 1884 (Fig 4) shows the increasing expansion within the area of the SUB29 site with buildings now on both sides of Hare Lane and Park Street and also along the north and south of St Catherine Street. A large vinegar works is marked to the north of the St Catherine Street and Skinner Street corner. The 1852 Board of Health map shows this as a

'Parchment Manufactory' in a much smaller building. The 1891 Goad insurance plan of the factory site records it as 'John Stevens, Sons & Co Gloucester Vinegar Works Jam and Pickle Factory'. It stretched from a long range fronting Skinner Street (marked Roman Road on the plan) westwards to the rear of 14 and 16 St Catherine Street. The buildings shown on St Catherine Street are marked as tenements with the public house of the Coach and Houses on the corner. The 1902 Ordnance Survey (Fig 4) shows how built up the area around the SUB29 site has become by this time but the SUB29 site still has open space in the back plots between Hare Lane and Worcester Street. To the north can be seen the Vinegar Works which has further expanded and on the 1923 Ordnance Survey (Fig 4) the Works have been extended even more so that they now cover most of the land north of the buildings on St Catherine Street and south of the River Twyver. The area of the SUB29 is still shown with buildings along its western edge and open space behind, although has now been divided.

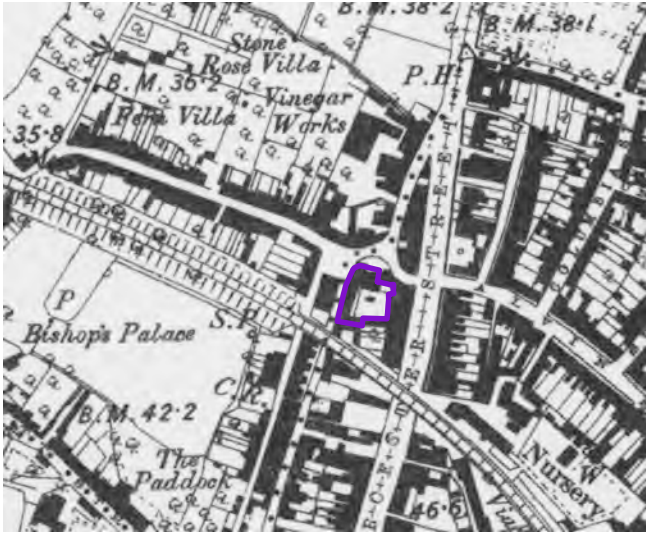
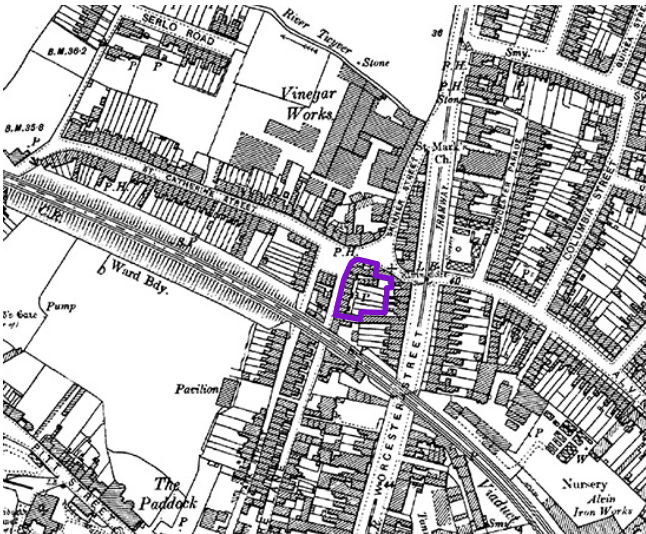
Figure 4 - Historical mapping

The Ordnance Survey of 1938 (Fig 4) shows little change with the exception of a further extension to the Vinegar Works and, to the south of the railway viaduct, a number of buildings have been demolished and replaced with a larger structure. The scale of the 1942 Land Utilisation Survey is too small to show much detail. The entire area around the SUB29 site is coloured red on the map, indicating that it was 'Land so closely covered with houses and other buildings or industrial works as to be agriculturally unproductive'. The 1955 Ordnance Survey (Fig 4) shows a number of small changes in the area around the SUB29 site but not within the site itself. On St Catherine Street, numbers 16 and 34 to 44 have been demolished giving greater access into the Vinegar Works. By the time of the 1970 Ordnance Survey (Fig 4) the Vinegar Works, now called Exhibition Works, have expanded greatly to the west and more buildings have been demolished both in St Catherine Street and Hare Lane. The buildings within the SUB29 site have been completely demolished with the site being marked as a car park. This is also the case with the northern part of Park Street which is also marked as a car park on this map. On St Catherine Street there are large open spaces shown on the north side of the street frontage between numbers 12 and 24 and between numbers 32 and 64. On the south there are also gaps between Catherine House (number 11) and number 21, between 39 and 43 and between 49 and 53. All of these demolitions were probably part of the slum clearances described earlier. The modern maps still show large spaces on the street frontages of St Catherine Street and also the car parks on Park Street and Hare Lane, the SUB29 site.
