SUB54 Land at Rea Lane

Site Historic Environment Assessments for Strategic
Assessment of Land Availability (SALA)

March 2015

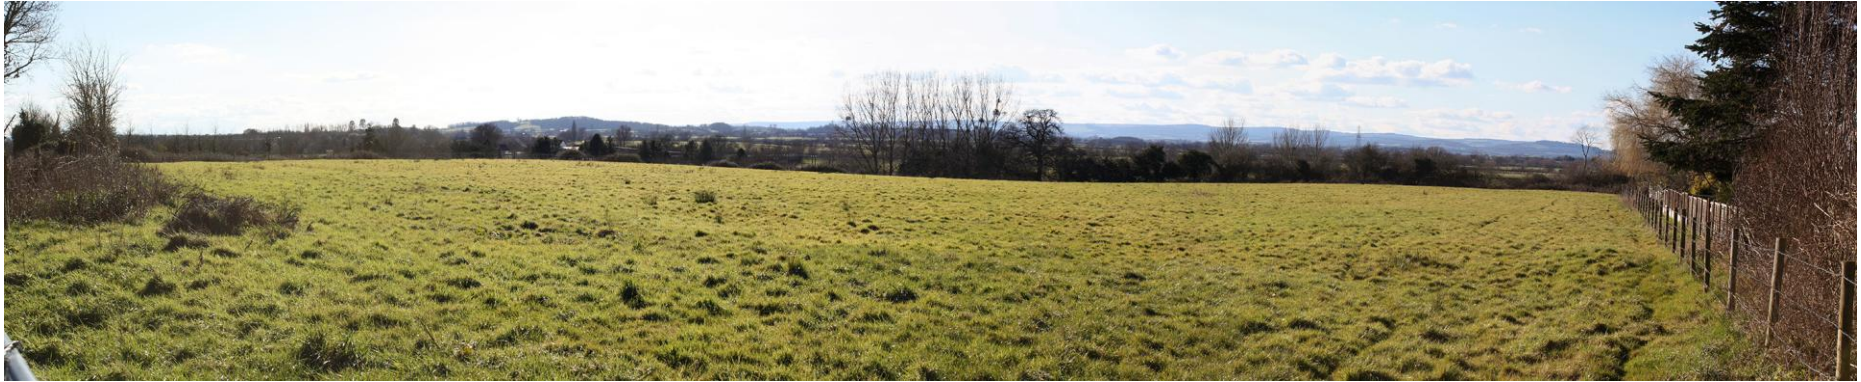
Plate I View of the site from the north east

The SUB54 site lies adjacent to Rea Lane and to the modern houses of Chartwell Close. It is currently well screened from all sides by mature hedgerows, trees and bushes.

Retention of the current hedgerows around the site would be an **enhancement** and would retain the rural feel of the area.

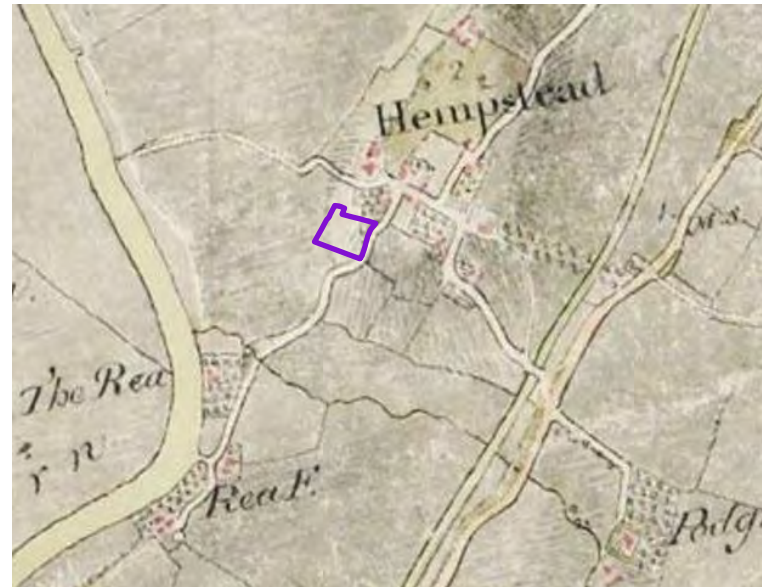
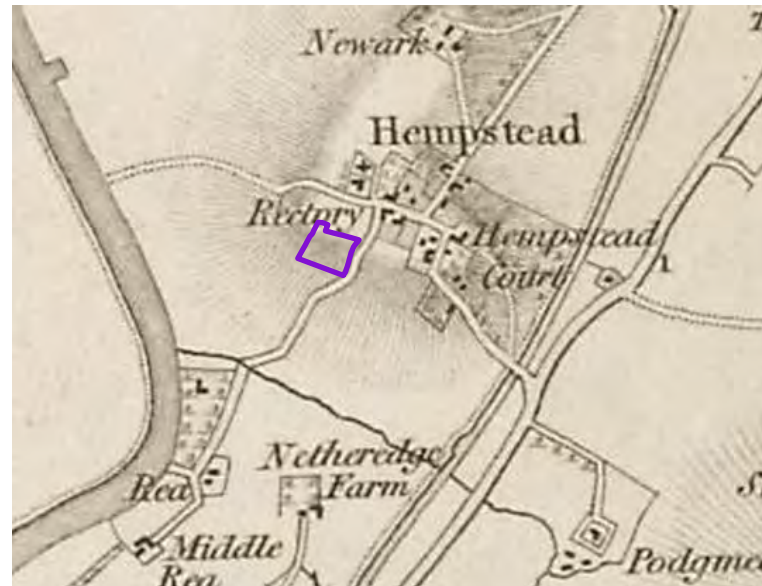
Figure 3 - Historical mapping

The early maps (Fig 3) of the area of the SUB54 site show little detail, however they do show the place names and it can be seen that Hempsted has altered its spelling through time. The 1583 Saxton map (Fig 3) shows that Hempsted was spelled in a simpler manner, just as 'Hemsted'. This spelling changes by the 18th century when the 'p' is added to make Hempsted on the 1794 Cary map (Fig 3) and then by the early 19th century the name is 'Hempstead' as seen on the Dawson map of 1811. It is on this map (Fig 3) that the first detail of the area is shown although little more than the lanes and field boundaries can be seen. Similar information is shown on the 1831 Ordnance Survey (Fig 3) and the hill on which Hempsted is located can be easily seen on this map.

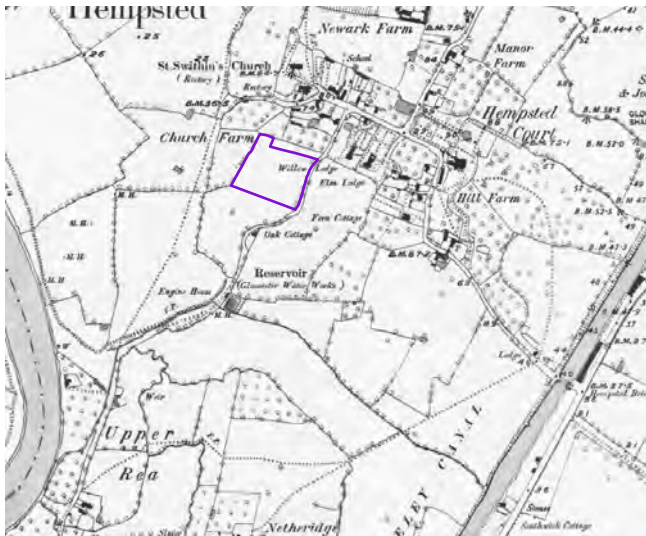
1884 Ordnance Survey

The first of the more detailed maps is the first edition Ordnance Survey of 1884 (Fig 4). This map shows the SUB54 site as part of a larger field to the south of Church Farm and bounded on the east by Rea Lane. The 1903 Ordnance Survey (Fig 4) shows no change in the site or in Hempsted except for the construction of a lane between Hempsted Lane and Rea Lane to the east of the site. The 1934 Ordnance Survey (Fig 4) again shows no change within the site and within the village, a small number of new houses have been built. To the east, adjacent to the canal, the Standard Match Factory has been constructed.

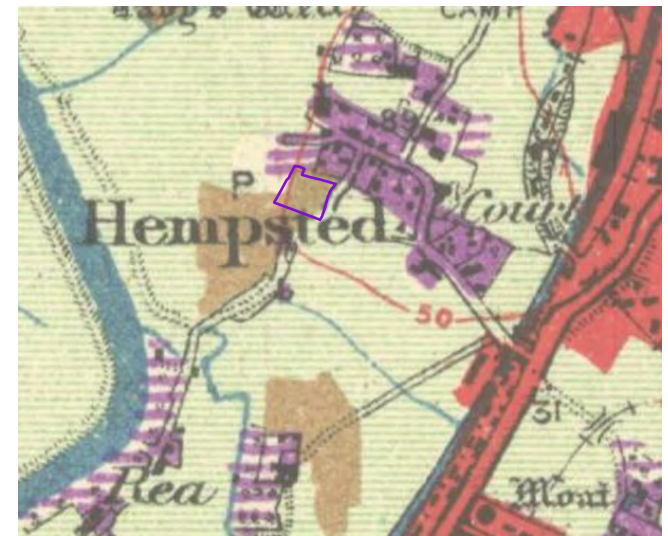
1942 Land Utilisation plan

The 1942 Land Utilisation Survey (Fig 4) shows the SUB54 site shaded in brown indicating that at this time the field was 'arable land – including fallow, rotation grass and market gardens'. The Ordnance Survey of 1955 and 1956 (Fig 4) shows the expansion of Hempsted village to the north and north east of the SUB22 site with new houses on High View in the process of being constructed and a lot more houses along the eastern end of Hempsted Lane. Up to date mapping shows that the expansion of Hempsted continued in the rest of the 20th century, including the construction of the South Western Bypass.
