SUB59 9-11 St Catherine Street

Site Historic Environment Assessments for Strategic  
Assessment of Land Availability (SALA)

June 2016

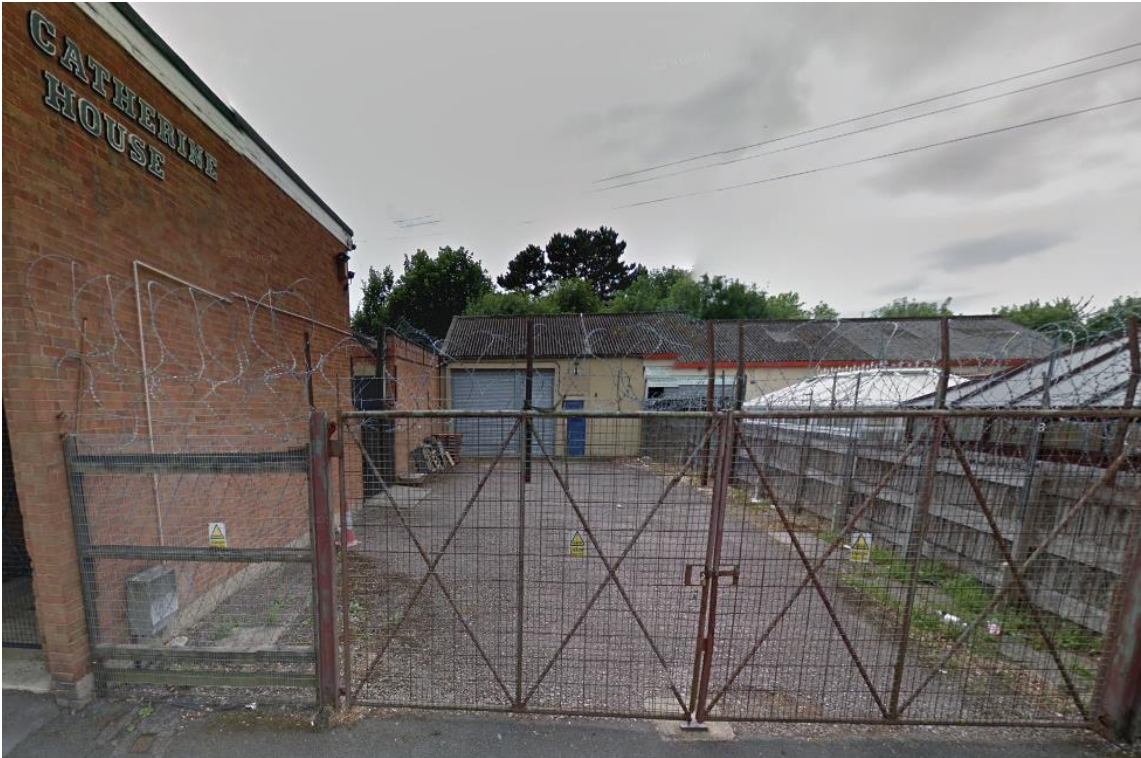
Plate 1: Part of the SUB59 site from the north

Removal of the razor wire and metal fencing St Catherine Street boundary to the site and replacement with a more in-keeping form of fencing would be an **improvement** to the area.

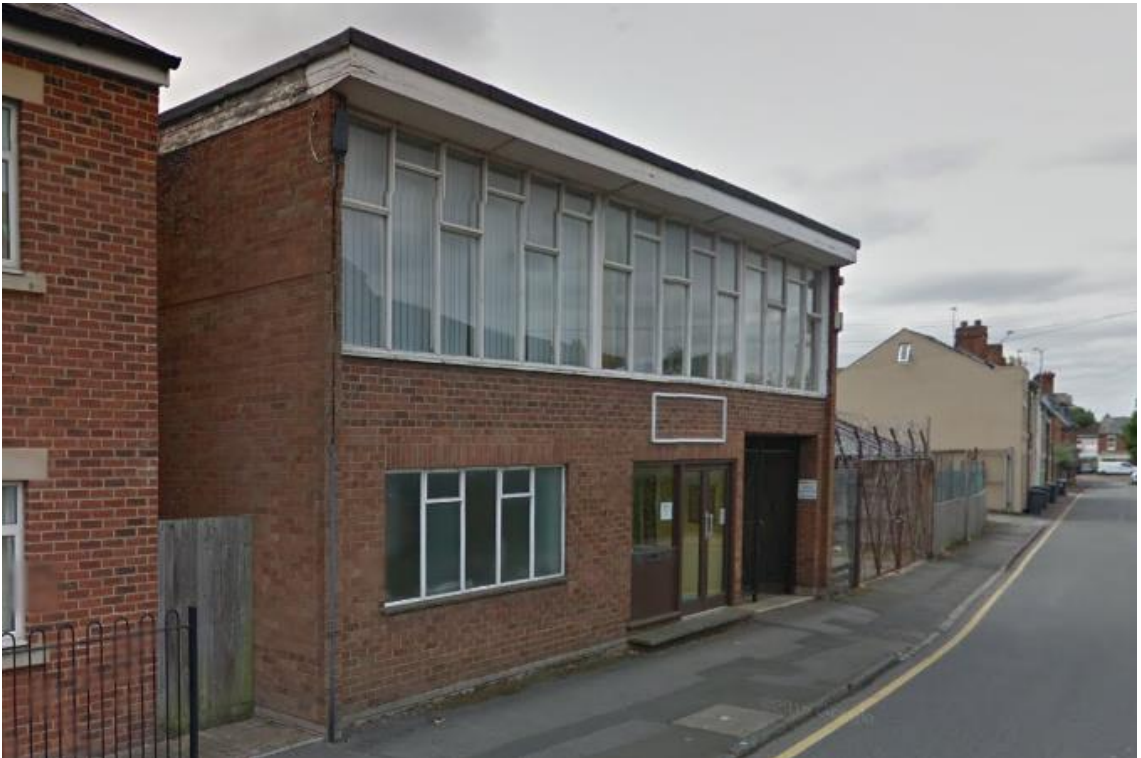
Plate 2: Part of the SUB59 site from the north east

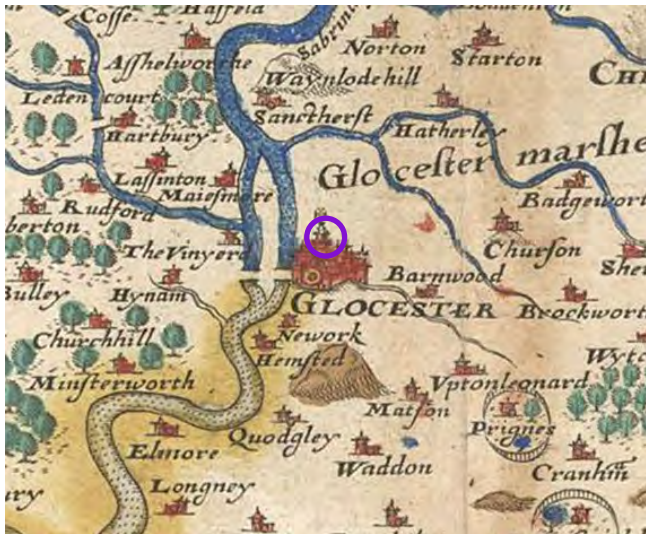
1583 Saxton map

The earliest historic maps of the area of the SUB59 site are not very detailed. The Saxton map (Fig 3) of the later 16<sup>th</sup> century shows only settlements with churches and the River Severn with Gloucester very prominent. Kingsholm is not separately shown on this map, nor is it shown on the 1646 Blaeu map (Fig 3) which is very similar. The 1794 Cary map (Fig 3) includes roads and shows Gloucester prominently but does not have any other detail of the city. The first map showing any detail of the area is a 1799 map of Gloucester which shows the SUB59 site as an open area with one building in the north west on the St Catherine Street frontage. The 1805 Cole and Roper plan (Fig 3) also has a building in the north east of the SUB59 site with most of the rest of the site marked as a garden. The buildings of Hare Lane and St Catherine Street are clearly visible on this 1805 plan and the gardens to the north of the latter are labelled 'Chapel House Garden'. The scale of the 1831 Ordnance Survey (Fig 3) is too small to show a great amount of detail but it does show the built up area of St Catherine Street. The new Worcester Street is clearly visible running out to Kingsholm. The 1852 Board of Health maps (Fig 3) of the area show that by this time there are two adjoining buildings within the north east of the SUB59 site. The railway viaduct is clearly shown crossing this map along with the built-up areas of the south part of Hare Lane and the northern side of St Catherine Street.

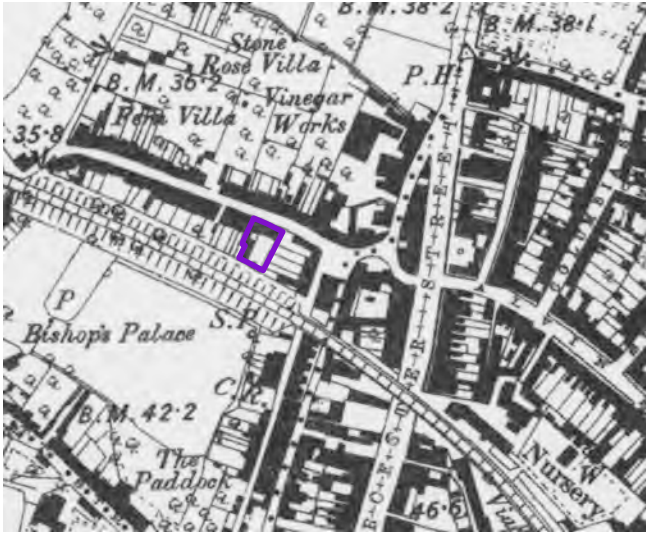
1884 Ordnance Survey

The Ordnance Survey 1<sup>st</sup> edition of 1884 (Fig 4) shows the increasing expansion within the area of the SUB59 site with buildings now along the north and south of St Catherine Street and also on both sides of Hare Lane and Park Street. The street frontage of the SUB59 site is shown as completely covered with buildings. A large vinegar works is marked to the north of the St Catherine Street and Skinner Street corner. The 1852 Board of Health map shows this as a 'Parchment Manufactory' in a much smaller building. The 1891 Goad insurance plan of the factory site records it as 'John Stevens, Sons & Co Gloucester Vinegar Works Jam and Pickle Factory'. It stretched from a long range fronting Skinner Street (marked Roman Road on the Goad plan) westwards to the rear of 14 and 16 St Catherine Street. The buildings shown on St Catherine Street are marked as tenements with the public house of the Coach and Houses on the corner. The 1902 Ordnance Survey (Fig 4) shows how built up the area around the SUB59 site has become by this time but the SUB59 site still has open
