SUB22 Land south of Hempsted

Site Historic Environment Assessments for Strategic
Assessment of Land Availability (SALA)

March 2016

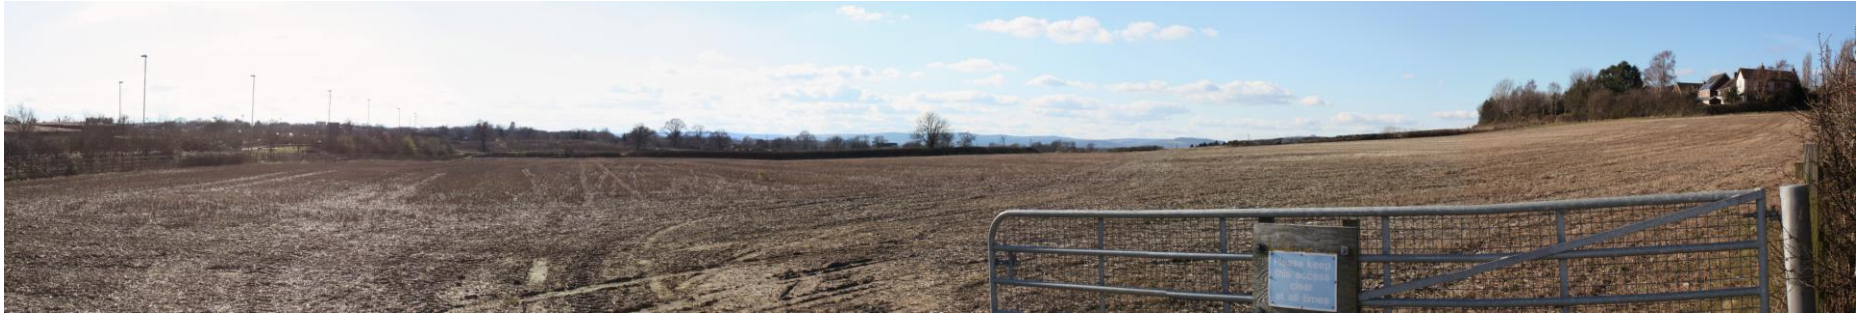
The SUB22 site sits lies on the slope down from Hempsted village and is very visible from the south and south east, especially from the A430 Secunda Way (Hempsted Bypass). From Rea Lane in the west, the views of the site are hidden by hedgerows with the exception being the south west, by the two cottages adjacent to the south west boundary of the site, where the view from the site up the slope to Hempsted village is unimpeded. From Hempsted Lane, the view of the site and beyond to the south is hidden by a mature hedge.

Plate 1 View of the site from the north east

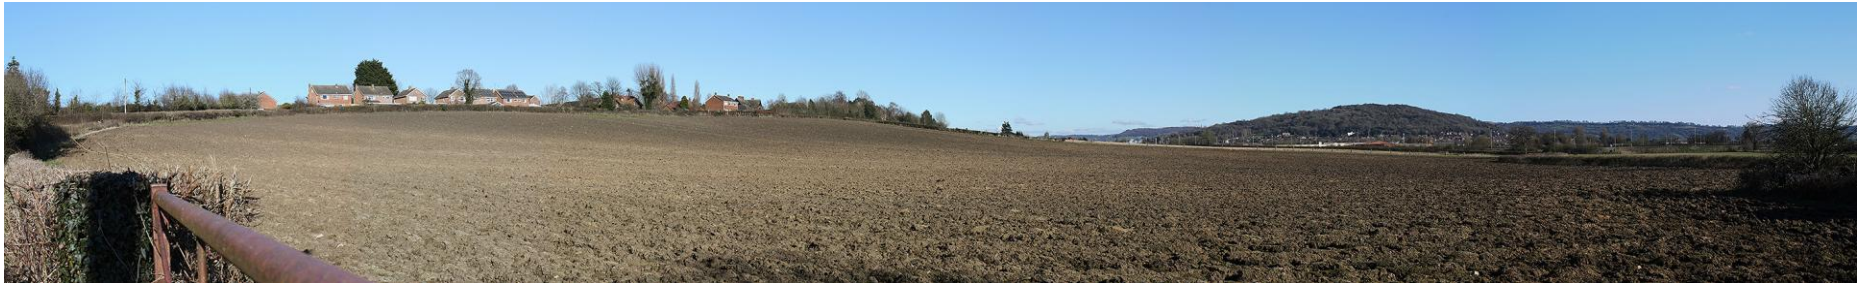
Plate 2 View of the site from the south west

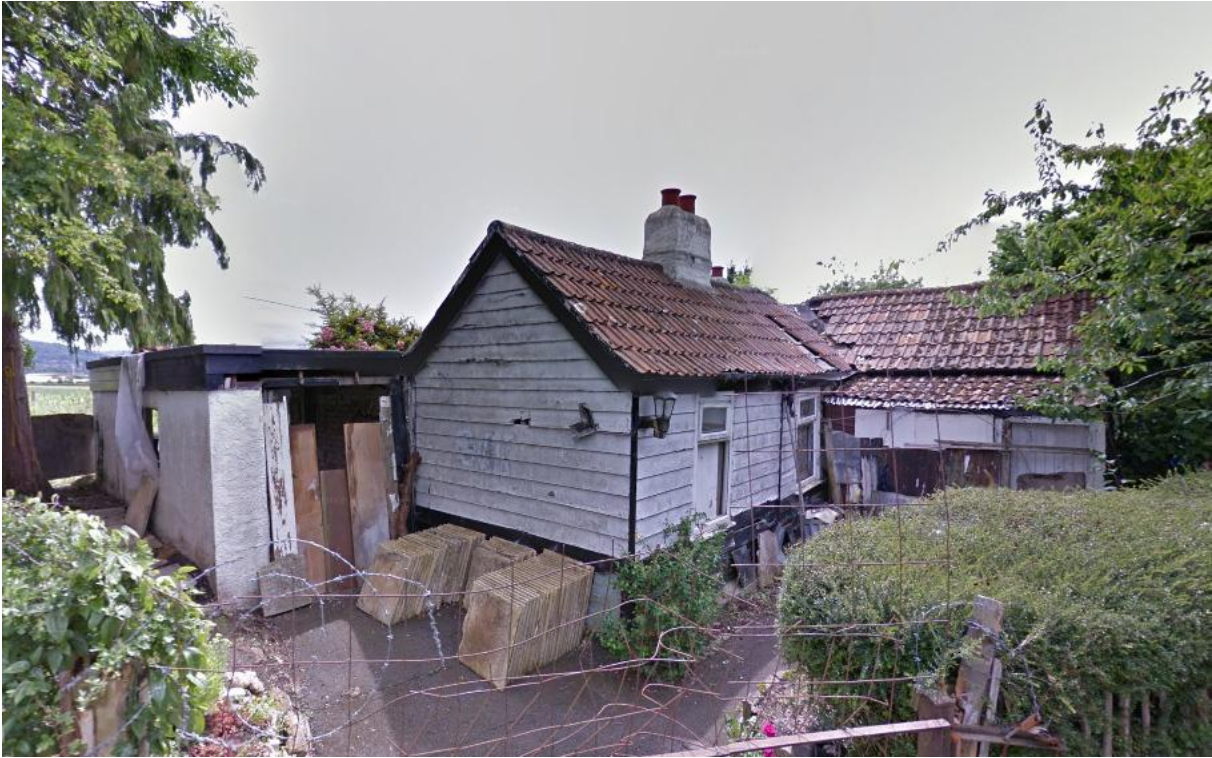
Within the area around the SUB22 site there are also a number of surviving unlisted post-medieval buildings. On Rea Lane is a small building called Oak Cottage. This building is marked on historic maps and still survives although planning permission has been approved for its demolition and replacement. On Hempsted Lane a pair of houses, numbers 133 and 135, were constructed at the end of the 19th century within large gardens. The gardens have now been built upon and the houses are completely surrounded by the later structures of Bridge Close. Fairmead House, 123 Hempstead Lane, is also of late 19th century date. Set back from the road in its own grounds it is a typical late Victorian villa. In a prominent, central position in the village is Milocroft, 115 Hempsted Lane. It is a 'brick house with half-timbered gables by W B Wood, 1892' (Verey and Brooks 2002, p535). Much of the rest of Hempsted is 20th century in date, replacing the earlier houses and farms of this pastoral village.

Development within the whole of the SUB22 boundary would include the demolition of the historic Oak Cottage. This historic structure is shown on the Ordnance Survey first edition map of the 1880s and demolition would cause **Major Harm** to the heritage asset.

Plate 3 View of Oak Cottage from the north west

The retention of the historic Oak Cottage would be an **enhancement** to the site.

- Retention of Oak Cottage as part of any scheme of development.
- Retention of the existing hedgerows. Additional screening to be added where needed to reduce the visual impact of development.

- Historic building assessment of Oak Cottage, in order to decide if the buildings should be added to the local list, in line with relevant guidance produced by the ClfA (ClfA 2014e) and Historic England (EH 2006).

- Recording of Oak Cottage in line with relevant guidance produced by the ClfA (ClfA 2014e) and Historic England (EH 2006).
- Key views should be retained within any development.

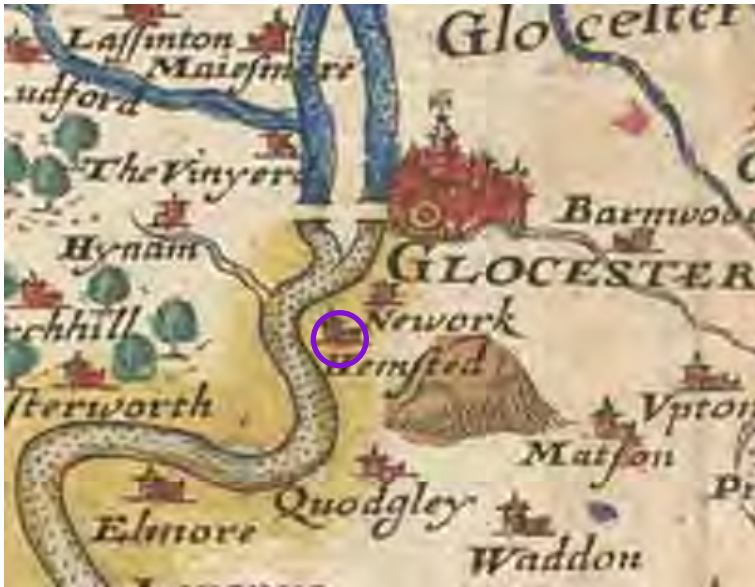
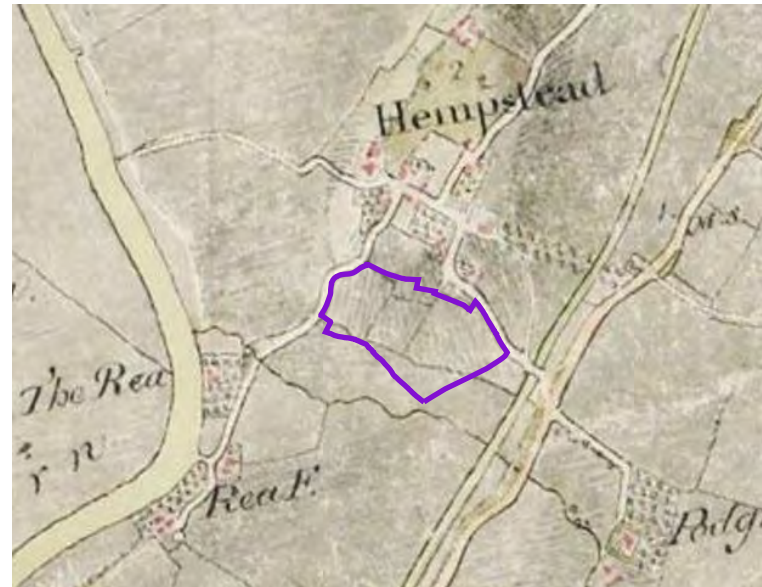
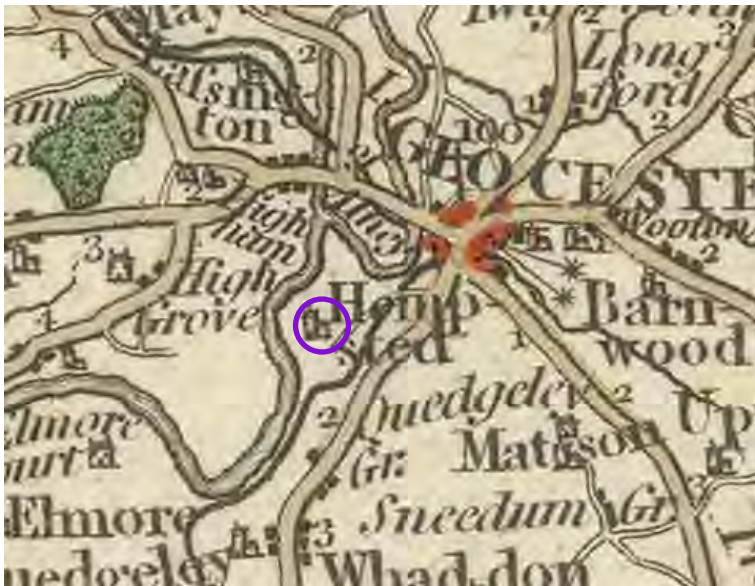
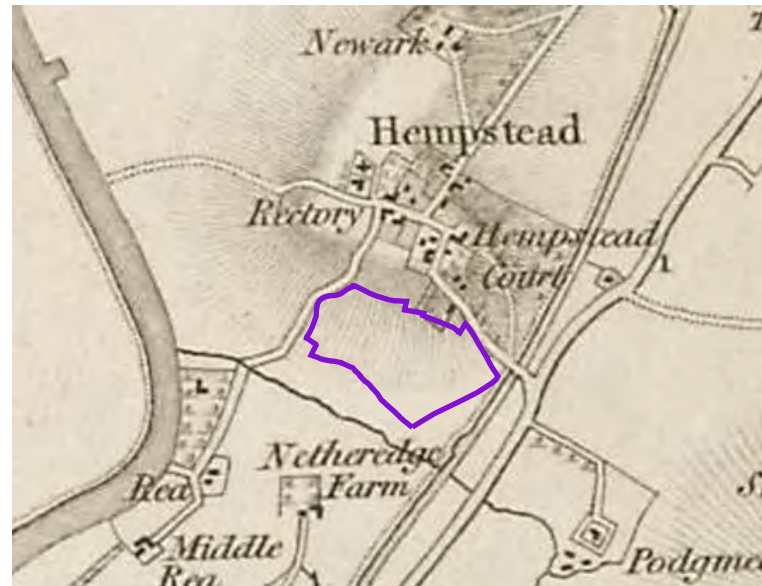
Figure 3 - Historical mapping

The early maps (Fig 3) of the area of the SUB22 site show little detail, however they do show the place names and it can be seen that Hempsted has altered its spelling through time. The 1583 Saxton map (Fig 3) shows that Hempsted was spelled in a simpler manner, just as ‘Hemsted’. This spelling changes by the 18th century when the ‘p’ is added to make Hempsted on the 1794 Cary map (Fig 3) and then by the early 19th century the name is ‘Hempstead’ as seen on the Dawson map of 1811. It is on this map (Fig 3) that the first detail of the area is shown although little more than the lanes and field boundaries can be seen. Similar information is shown on the 1831 Ordnance Survey (Fig 3) and the hill on which Hempsted is located can be easily seen on this map.

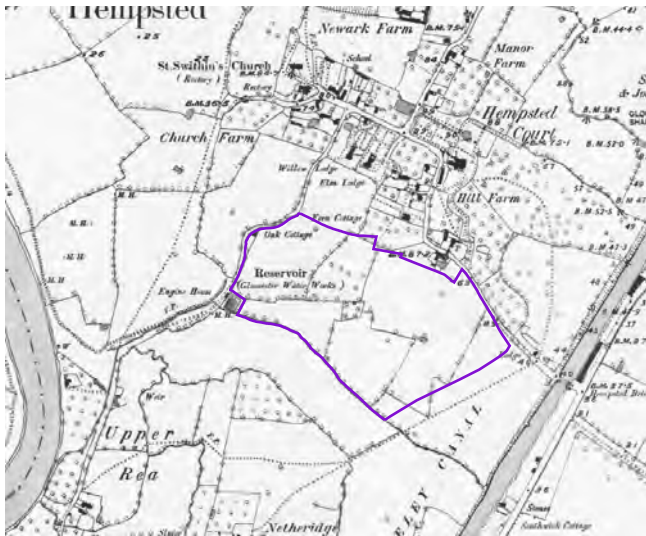
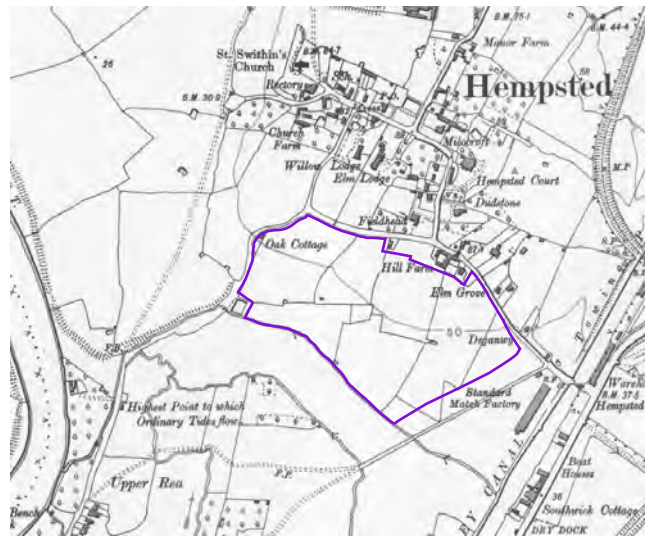
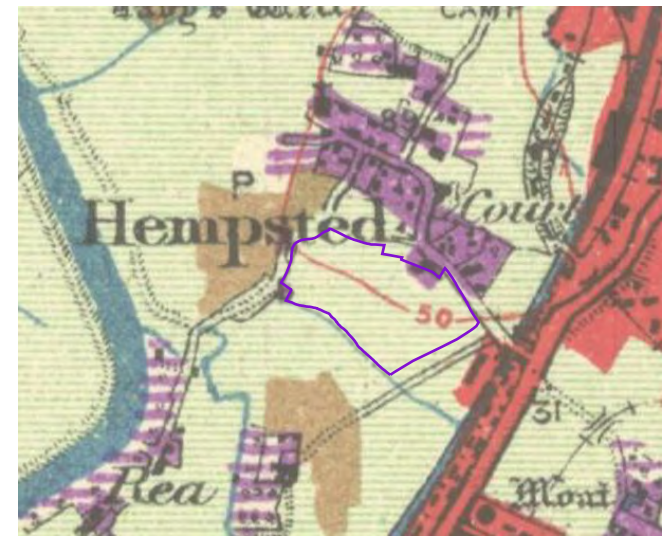
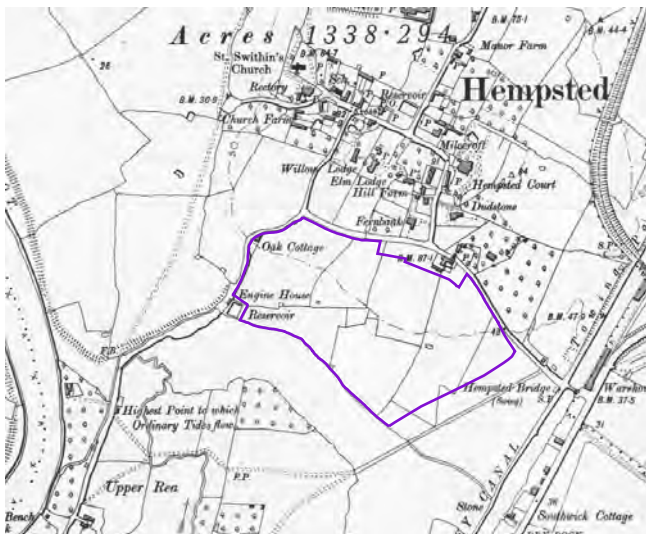
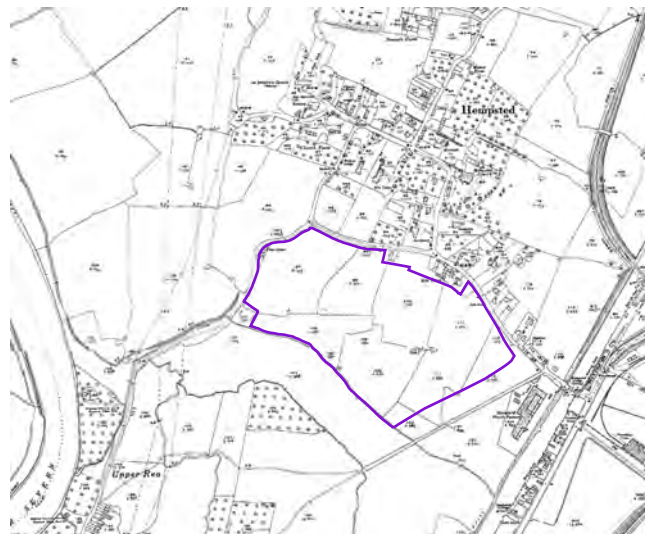
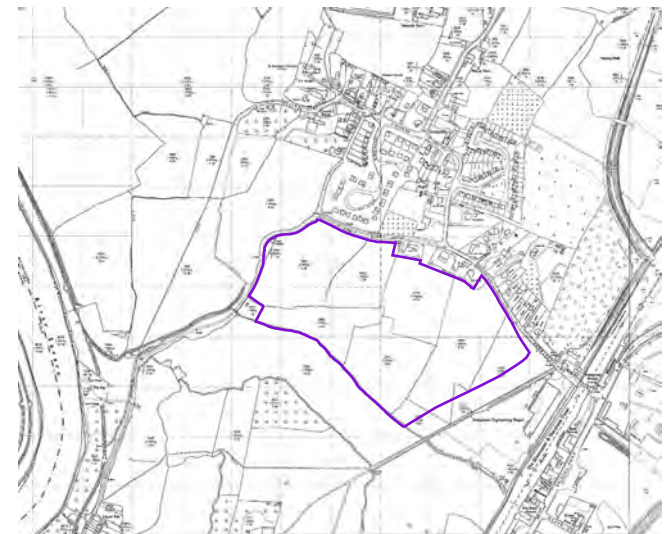
Figure 4 - Historical mapping

The first of the more detailed maps is the first edition Ordnance Survey of 1884 (Fig 4). This map shows the SUB22 site as a number of fields to the south of Hempsted village with open space between the fields of the site and the village itself. Oak Cottage can be seen in the west of the area and outside the south west boundary are a Gloucester Water Works Reservoir and Engine House. The bank protecting the meadow fields to the west can be seen and the field boundaries within the site are very irregular. The 1903 Ordnance Survey (Fig 4) also shows the irregular field boundaries and a number of small ponds within the site. Along the north boundary, a new lane has been created between Hempsted and Rea Lanes. The next map, the 1924 Ordnance Survey (Fig 4), shows no change at all in the site and very little in the village with the exception of the construction of the Standard Match Factory alongside the canal and a small number of new houses to the north east of the site. The 1936 map (Fig 4) shows that the match factory has been extended and the number of houses at the east end of Hempsted Lane has increased, including to the immediate north of the SUB22 site. Within the site itself one of the field boundaries has been removed and the reservoir to the south west has been removed.

The 1942 Land Utilisation map (Fig 4) shows the land of the SUB22 site coloured with horizontal green stripes showing that the land was 'meadowland and permanent grass'. The Ordnance Survey of 1955 and 1956 (Fig 4) shows the expansion of Hempsted village to the north and north east of the SUB22 site with new houses on High View in the process of being constructed and a lot more houses along the eastern end of Hempsted Lane. Up to date mapping shows that the expansion of Hempsted continued in the rest of the 20th century, including the construction of the South Western Bypass, although development within the SUB22 site was restricted to the removal of most of the historic hedgerows.
